# **SANDIA REPORT**

SAND2015-1164

## **Improvements to address issues leading to cancellation of the July 2014 plutonium experiment**

Overview: A Pu shot scheduled for July 17 on the Z machine at SNL was cancelled this past summer. The LiF windows on the Pu targets were cracked during assembly because of configuration changes. Sandia management concluded that continuing with this experiment would present an unacceptable level of risk to the facility and possibly to the workers. In this report, we document the events that occurred which led to this decision and also present some lessons learned and plans and procedures put in place to reduce the likelihood of another such occurrence. The changes and this memorandum reflect the thinking of subject matter experts at both LANL and SNL. These changes represent significant improvements in both communication protocols and quality of the hardware assemblies.

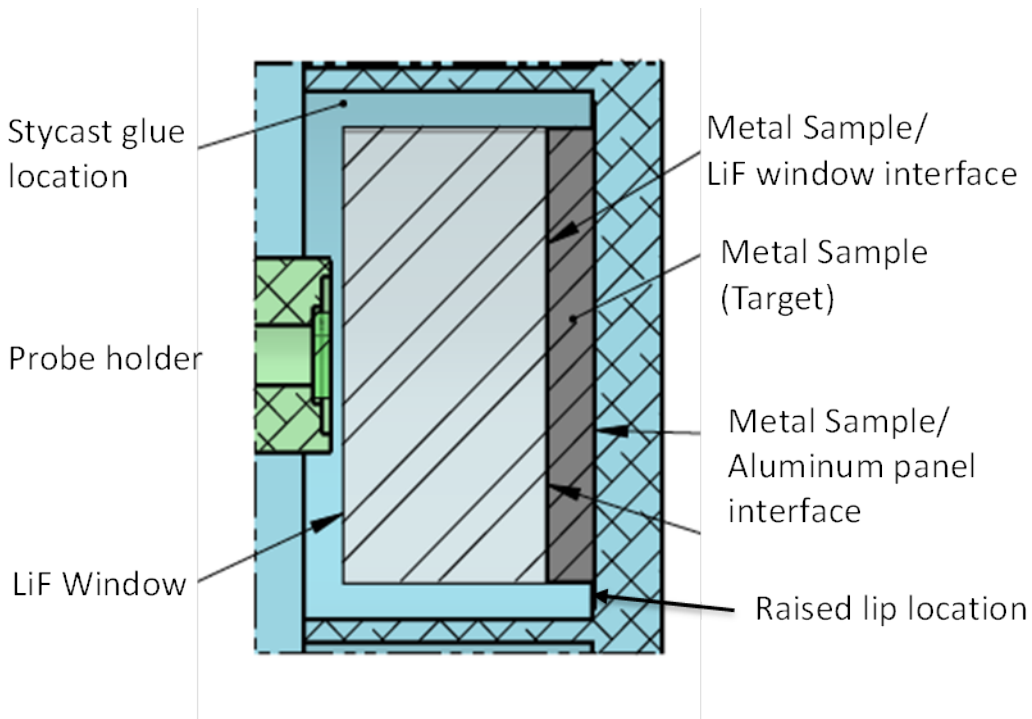
**Figure 1. Target assembly drawing showing region that contains the metal disk.**

For this particular experiment, a few changes occurred that produced some unforeseen results that compromised the perceived integrity of the target. First, the panel was modified slightly by increasing the diameter of the counterbore by .020" (0.5 mm). This was done for two reasons. To meet particular experimental objectives the diameter of the sample was slightly increased, resulting in a sample/window stack where the sample and window were the same diameter. The increased sample diameter prompted a corresponding increase in the counterbore diameter to accommodate the fact that the bottom inside corner of the counterbore has a small radius (caused by the radius of the lathe tool) and is thus not absolutely flat. There was concern that without an increase in the diameter of the counterbore the larger diameter sample might "ride up" this radius, thereby compromising the mechanical integrity of the glue bond.

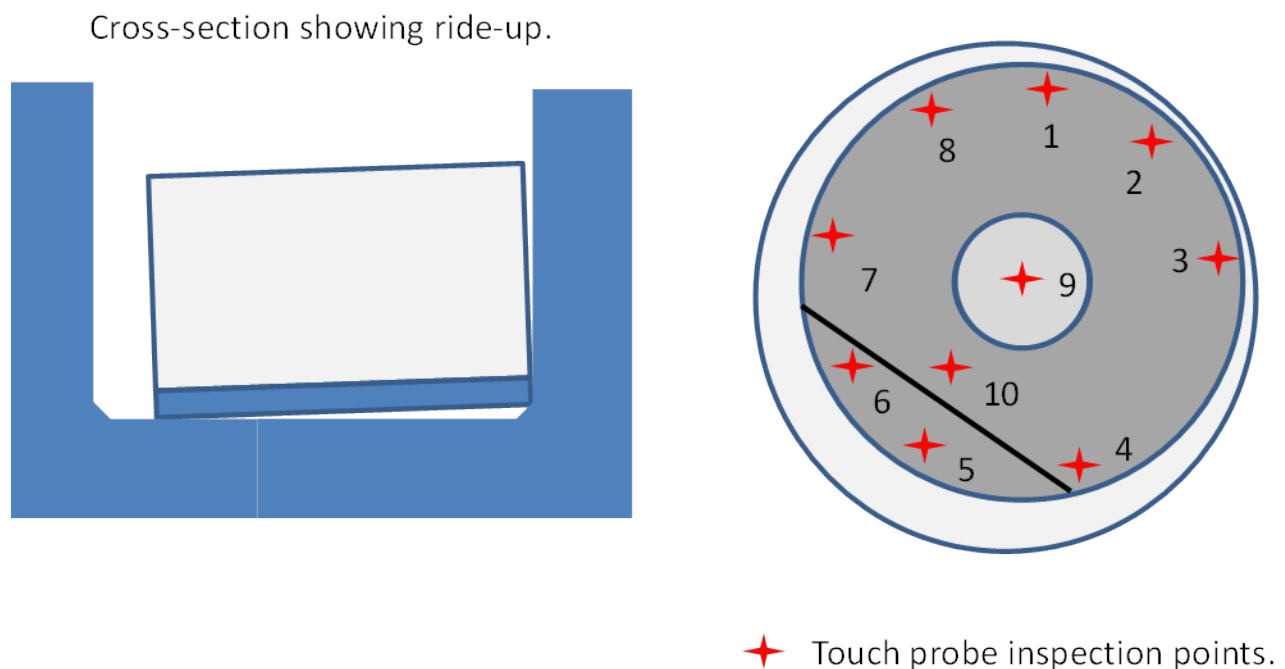
During assembly the sample/window stack migrated toward the counterbore wall, resulting in the sample “riding up” the radius at the bottom of the counterbore, as shown in Figure 2. With the sample not sitting flat on the counterbore face the pressure used to hold the window into place cracked the window. The implications of these cracks in the windows were not fully appreciated right away. The staff at LANL understood these were not expected and could cause problems, so they took several steps to determine the implications for the experiment and for preventing contamination that could result from the cracks.

**Figure 2. Drawing of position of target sandwich in the cylindrical sleeve and the position of the crack.**

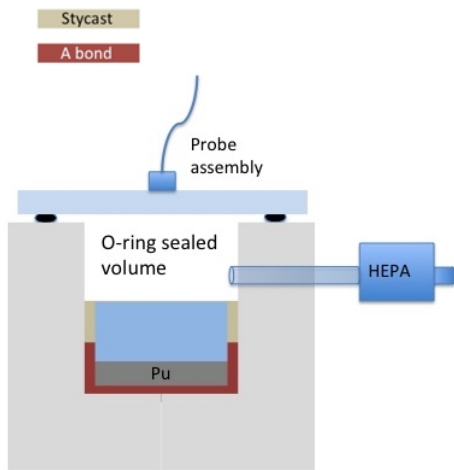
Figure 3. Illustration of the second (O-ring) seal. The seal is leak tested by over-pressurizing the volume inside the cell with He while in a vacuum chamber.

Another set of improvements focuses on the assembly and testing of the target. When assembling the target and gluing it into place, LANL will use a centering tool to keep the sample/window stack in the center of the counterbore. In addition, they will use a sufficient amount of Angstrom bond glue to fully encapsulate the metal target. This will fill the counterbore around the LiF window and enhance the seal produced by the stycast. An illustration of the new target configuration is shown in figure 3. LANL will also pull a vacuum on the target to ensure the stycast glue fills the area around the target sandwich uniformly. This should not only prevent the problem that occurred in this instance, it should also produce a more solid stycast seal. LANL and SNL assemblers and radiation protection experts agreed that these changes significantly improve the quality of the inner seal. Lastly, the vacuum integrity of the container will be checked by LANL after it is assembled using an overpressure test that includes measuring a He leak rate. This will ensure the integrity of the o-ring seal after final assembly. Finally, the procedure used at Sandia to unpack the sample will be modified to include a procedure for addressing a target that has become contaminated. This procedure will describe how to decontaminate the target and/or how to safely replace the target into a container that can be transported to a local storage area before shipping back to LANL. These changes, we believe, will improve not only the integrity of the targets themselves, but also our ability to understand and evaluate any changes or issues that may arise. As a result of these changes, both LANL and Sandia believe we have more knowledge of the state of these targets and can thereby make better determinations on whether we have done an adequate job of mitigating the risks associated with these experiments.
